## CLASSIFICATION OF VOLCANIC EFFECTS

## Rebuilding Rabaul

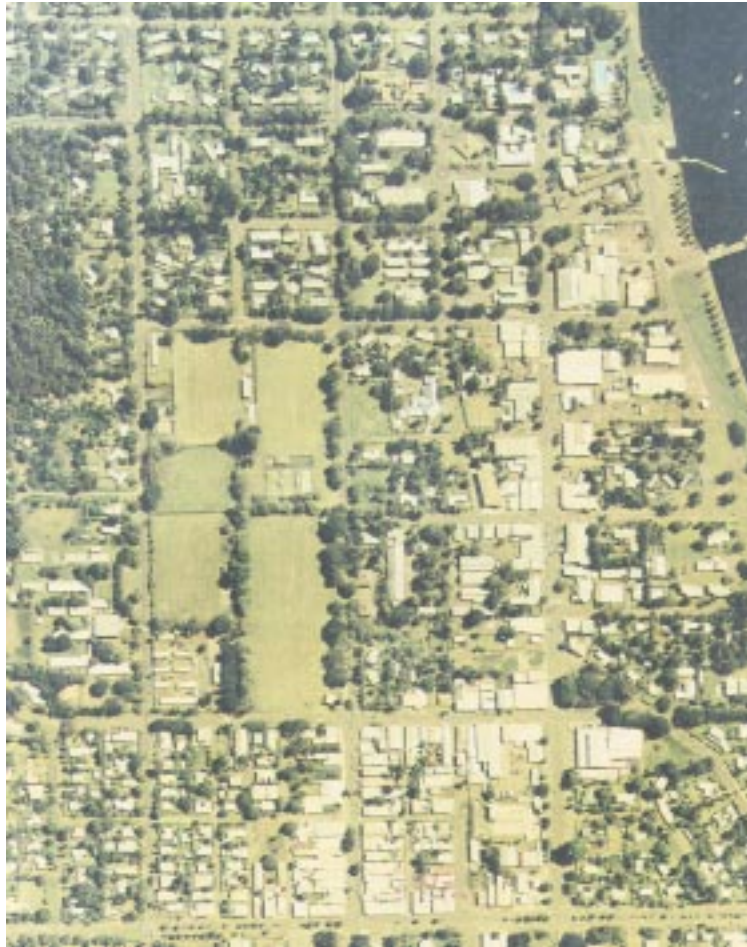
*Photo 4 Town Centre - pre-eruption*

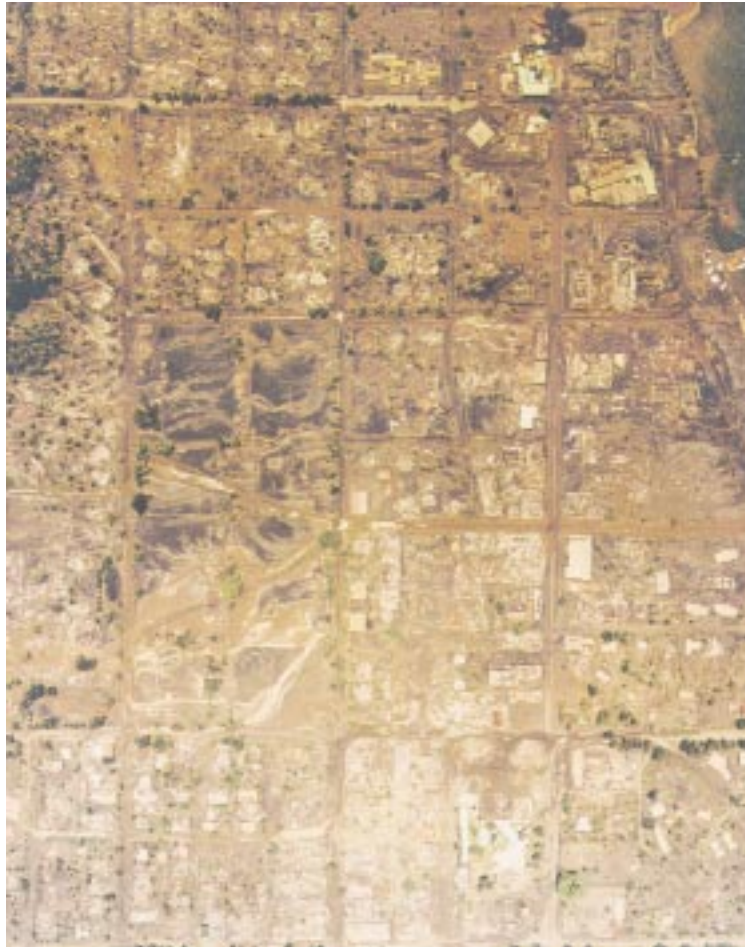
**Building Damage.** Most of the initial structural damage was caused by ashfall. It had been found that most buildings collapsed under 300mm of ash corresponding to an approximate live load of 5.4kN/m<sup>2</sup>. Over two thirds of the town was exposed to ash depths greater than 300mm.

*Photo 5 Town Centre - post eruption*
